Landslides and related features interpreted
from aerial photographs:
1:40,000 (Black and White) 1973.

LANDSLIDES AND RELATED FEATURES
OF THE JABEZ, KY, QUADRANGLE
by
Alfred R. Taylor and Roger E. Thomas
1982

U.S. Geological Survey
OPEN FILE MAP 82-653 (H-9)

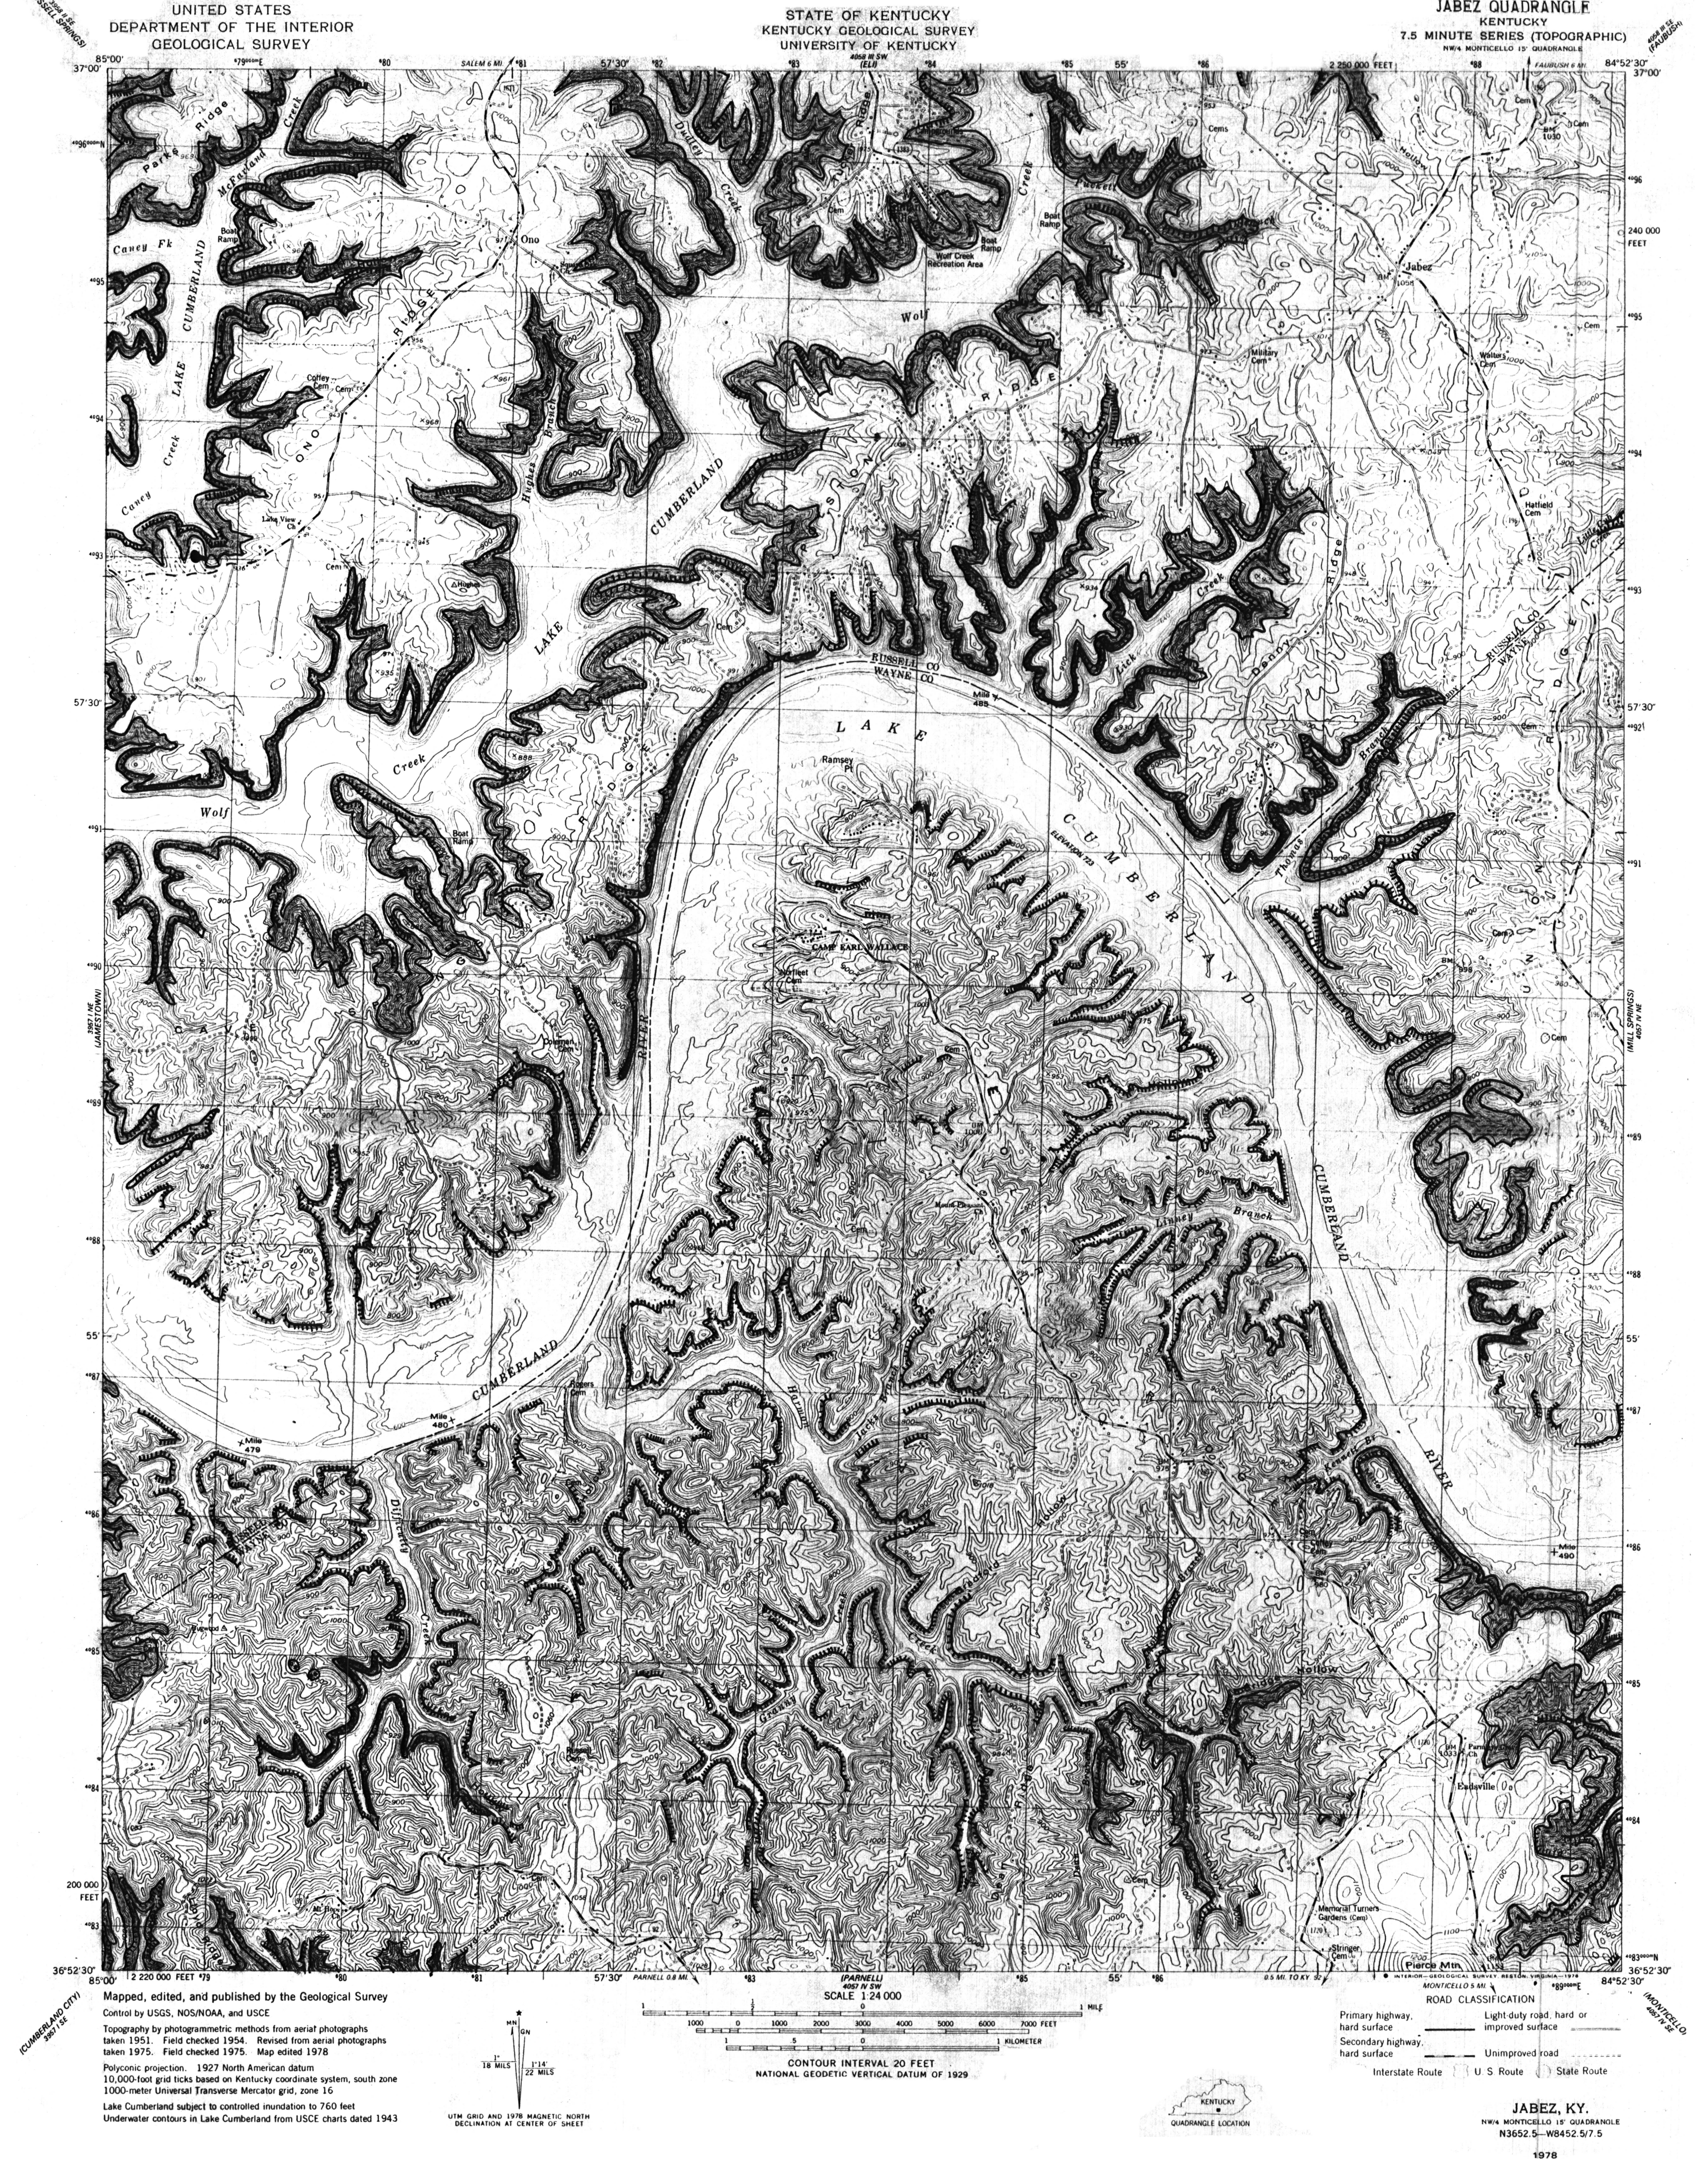
Photointerpretation 1979-1980
This report is preliminary and has not
been reviewed for conformity with U.S.
Geological Survey editorial standards.

- ACTIVE OR RECENTLY ACTIVE LANDSLIDE
Complex landslide composed of earthflow, debris
slide, earth and rock slump. Identified from
historical records, and from scars, debris and
other field evidence. Ground extremely unstable;
sliding accelerated by excavation, loading and
changes in drainage conditions. May include
areas with several active slides too small to
be shown separately. Questioned where doubtful.

- OLD LANDSLIDE
Area of extensive hummocky ground caused by
earthflow and earth and rock slump. Lacks
clear evidence of active sliding. Relatively
stable in natural, undisturbed state,
generally not affected by small structures properly
sited in areas away from the edge of the toe;
can be reactivated by extensive, rapid exca-
vation, loading, and changes in ground water and
surface water conditions. Area of old landslide
probably includes recent ones not identified
from field evidence or otherwise documented.
Upslope boundary of landslide generally defined
by modified scarp, but downslope (toe) may be
gradational and not well defined. Questioned
where doubtful.

- COMBINATION LANDSLIDE
Area of recent and old slides in which
individual slides are not identified.
- COLLUVIAL SLOPE
Valley wall along major streams with slope as
steep as 40° (85°); stony, clayey silt soil up
to 50 ft. (15 m) thick; commonly buttressed by
a terrace or bench at the toe of the slope; very
susceptible to sliding by cutting of toe area,
removal of terrace or bench, and overloading;
slide commonly activated without apparent cause.

- COLLUVIAL SLOPES WITH LANDSLIDES
Landslides too small or obscure to map
individually.
- AREAS SUSCEPTIBLE TO DEBRIS FLOWS AND DEBRIS
AVANCHES
Primarily shallow, narrow ravines and chutes with
accumulation of stony colluvium generally 10 ft.
(3 m) or less in thickness; susceptible to rapid
movement during intense rainfall. Most ravines
and chutes designated show evidence of former
debris flows and avalanches.

- AREAS SUSCEPTIBLE TO ROCKFALL
Steep, locally vertical, natural and man-made
slopes and cliffs, 15 ft. (4.5 m) or more high;
formed dominantly of sandstone, limestone, sandy
shale, mudstone and claystone. Interbedded mud-
stone, claystone and shale weather rapidly leaving
sandstone and limestone rock faces unsupported.

- SOIL AND ROCK SUSCEPTIBLE TO LANDSLIDING
Soil and rock similar to that involved in land-
slides elsewhere in map area; primarily areas
underlain by claystone, mudstone and shale
associated with other rock types. Rock weathers
rapidly on exposure forming clayey soil highly
susceptible to sliding. Includes coves (U-shaped,
shallow valleys) containing thick layers of clayey
soil that are very susceptible to sliding where
excavation breaks continuity of slope and where
overloaded by artificial fill.

AREAS LEAST PRONE TO LANDSLIDES
Map areas in which no patterns or symbols are shown;
primarily valley floors, ridge tops and broad
benches; modification by excavation and fill may
lead to local landslides.
